Subject: DELINEATION REPORT PROVIDED BY ELOS DATED 12-22-2014

Parish - Livingston

Acreage - 24±

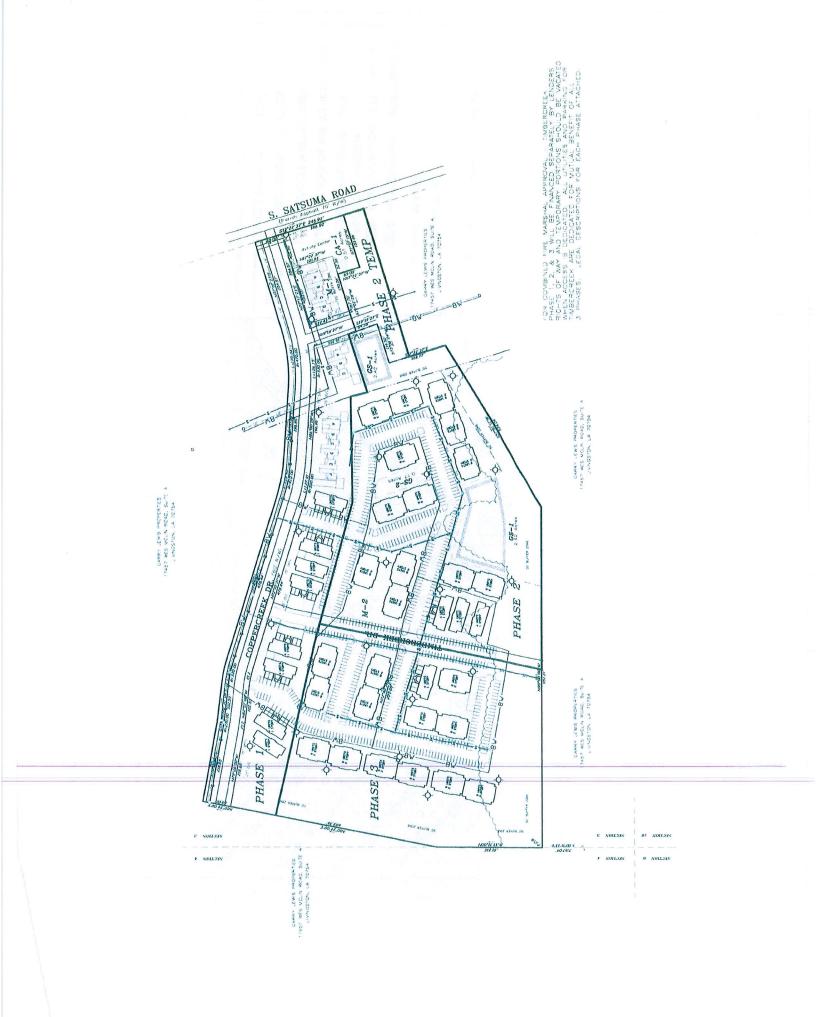
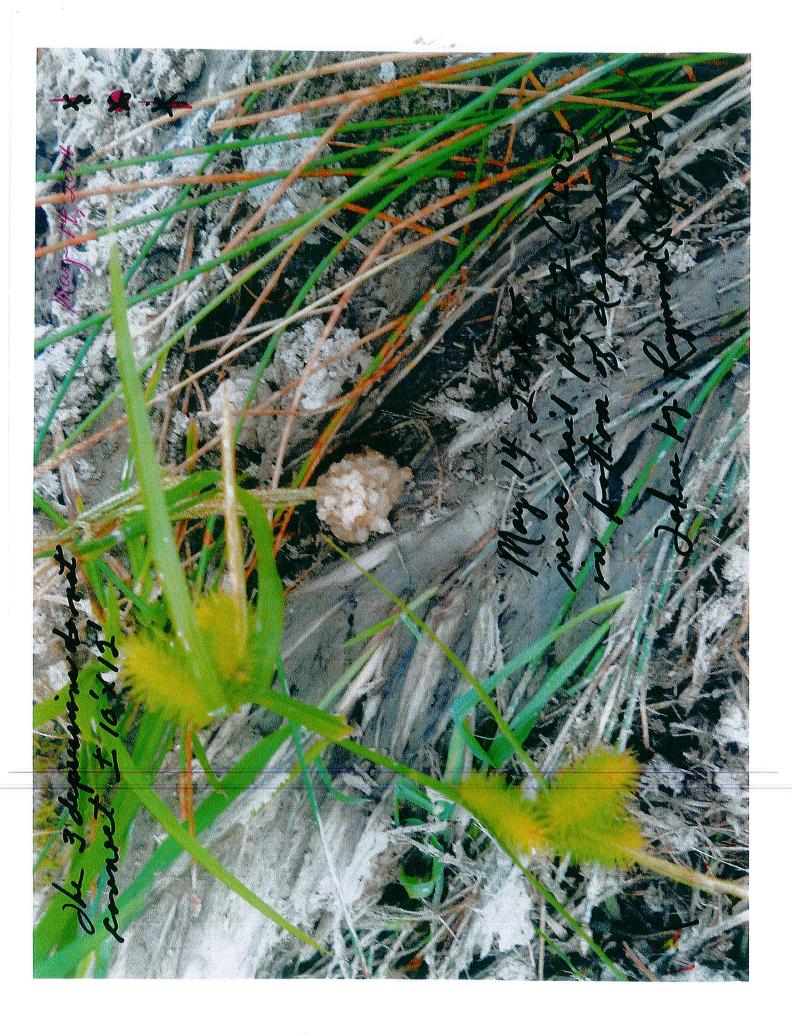
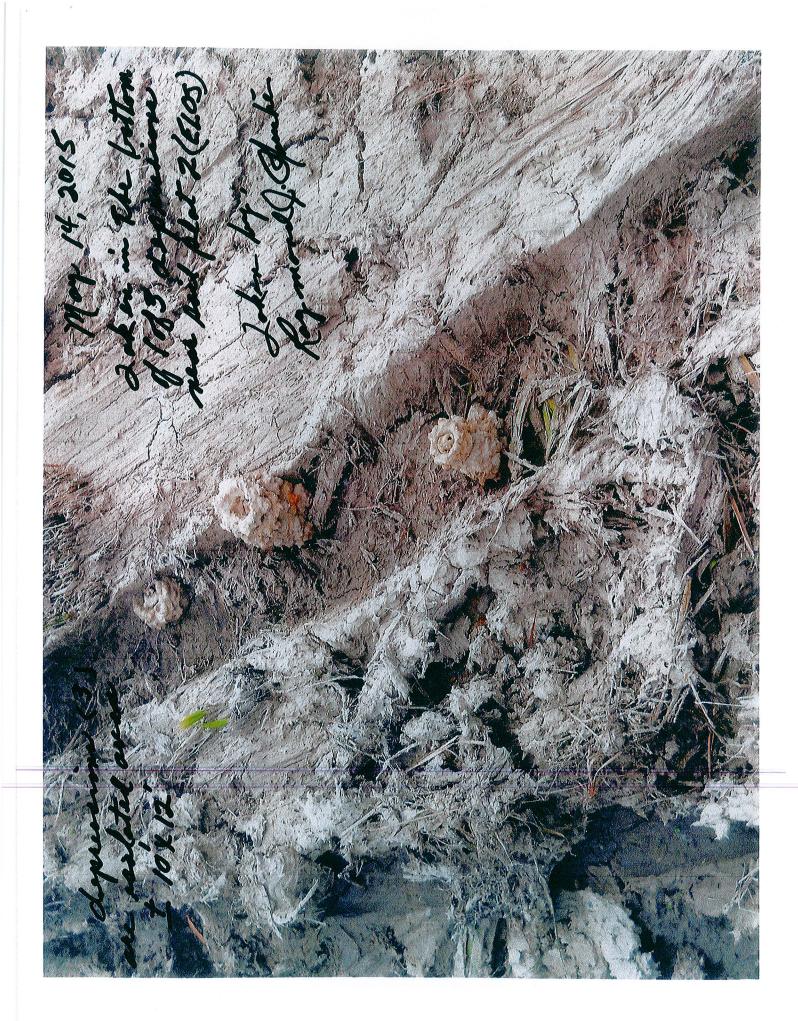
The Three (3) subject depressions on the following photos were investigated as potential isolated wetlands.

Their origin is from logging machinery. They are not manmade and they are not natural. The surface grey color is from dragging tree tops. The photos show the color and property of Satsuma ridge soil type being brought to the surface by crawfish. These depressions are absent the required soil type and the required vegetation is absent.
